Failure of Highway Fill and Investigation into Its Causes

Failure of Highway Fill and Investigation into its Causes

P. Jagannatha Rao

Dy. Director & Head, Geotechnical Engineering Division, Central Road Research Institute, New Delhi, India

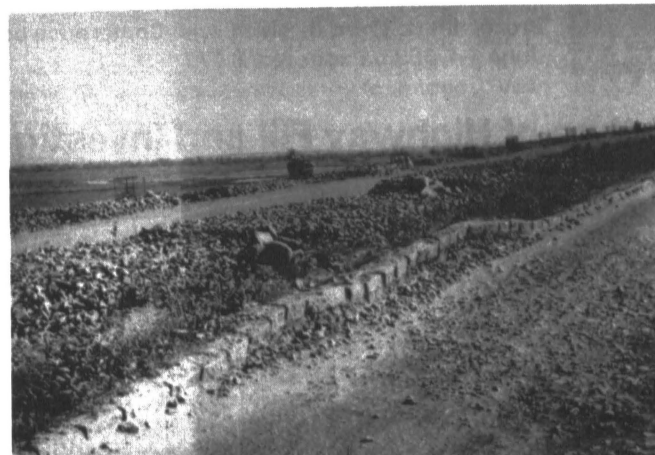
Fig.2 Typical transverse deformation

The stretch was opened to traffic in July 1982 and during the following three monsoon months, the pavement, especially the stretch over the approaches to the creek, experienced severe distress, which manifested itself in the shape of both longitudinal and transverse deformations, as well as formation of pot holes. Transverse deformations, longitudinal deformations and rutting had occurred where fill was upto 3m in height and the standing water was so high that little or no freeboard relative to the base of the pavement was available. A typical transverse deformation is shown in Fig. 2. Patch work on the damaged pavement can also be seen. Remedial measures such as filling of pot holes were adopted to maintain the road surface. Additional crust thickness was also provided. But the pavement continued to experience severe distress. Such an early failure of the pavement necessitated that the cause of such distress be identified. In this instance, the causes of the failure were not associated with the pavement thickness and thus detailed investigations were carried out to study the properties of fill material and the subsoil to find out the possible causes of distress. These investigations were essentially in the nature of getting first hand data regarding the fill material used, field densities achieved and the soaked CBR values of the subgrade.

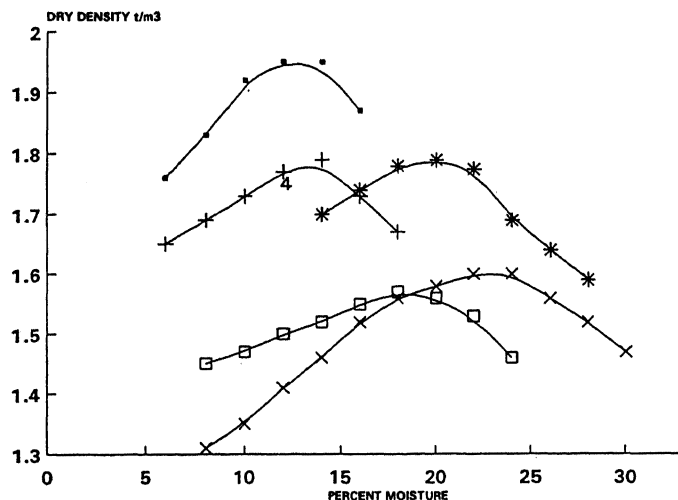
FIG.3 TYPICAL COMPACTION CHARACTERISTICS (MATERIALS SATISFACTORY AS FILL)

The maximum density as per standard Proctor compaction was high for this group of samples, and ranged from 1.8 to 1.9 t/m³. These materials were well graded, non-plastic or had a low plasticity index. Experience has shown that these are suitable as fills. In the present instance, pavements in the stretches located on such fill materials were performing satisfactorily. Typical compaction characteristics of satisfactory fill materials are shown in Fig.3.

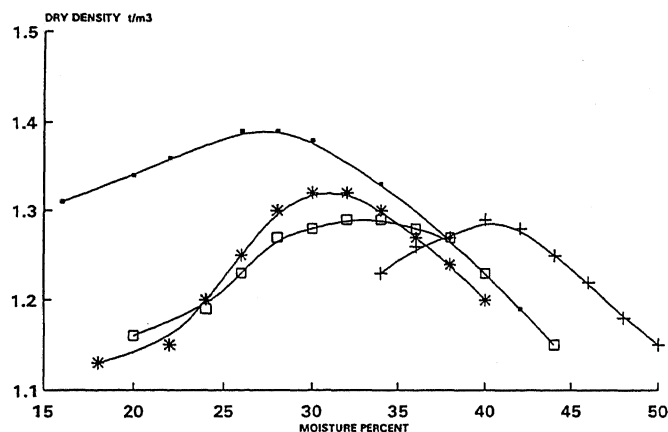
FIG. 4. COMPACTION CHARACTERISTICS (MATERIALS UNSATISFACTORY AS FILL)

The materials under this group represent fill materials having distinctly dissimilar properties to those from group A and group B. Typical compaction characteristics are shown in Fig. 4. It was found that all the materials in this group may be classified as inorganic silts or silty clays of medium to high compressibility i.e. ML to MH groups fig.5. These soils were found to be of non swelling nature and may be termed as inactive to normal, on the basis of Skempton's activity ratio. Standard Proctor density of these materials was found to be very low, of the order of 1.3 t/m³ only. Optimum moisture content ranged from 30% to 40% which is in the range of plastic limit of these soils. In the case study described earlier, major portion of the embankment on which the pavement was placed, was found to have been made up of materials of similar characteristics. In this embankment, it was

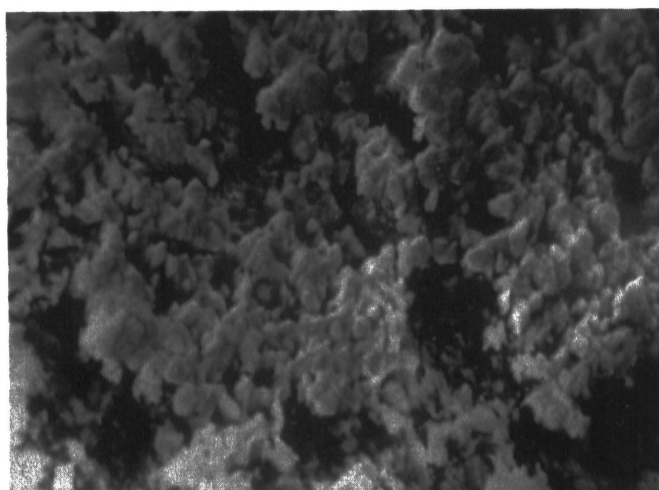
Fig.6 Limited Scanning Electron Micrograph of clay particles

found that even in the relatively dry season, insitu moisture content was high. Limited Scanning Electron Microscope (SEM) studies were carried out which indicated the likely presence of Allophane in the materials of this group. Fig.6 shows SEM of the clay particles magnified 10,000 times. Fill materials have low I_p combined with relatively high W_l and W_p . There is predominance of silt size particles in the soils. The materials are having low compacted density with high OMC. These materials were also found to retain significantly high water contents. Comparison of the properties of these materials with the properties of soils from other parts of the world show that these soil properties fit in very well with those of tropical residual soils derived from weathering of volcanic material, such as those found in Java (Wesley, 1973)
